A36 CONSTRUCTION UPDATE

A regular newsletter for residents and stakeholders in the Limpley Stoke area: Issue 7

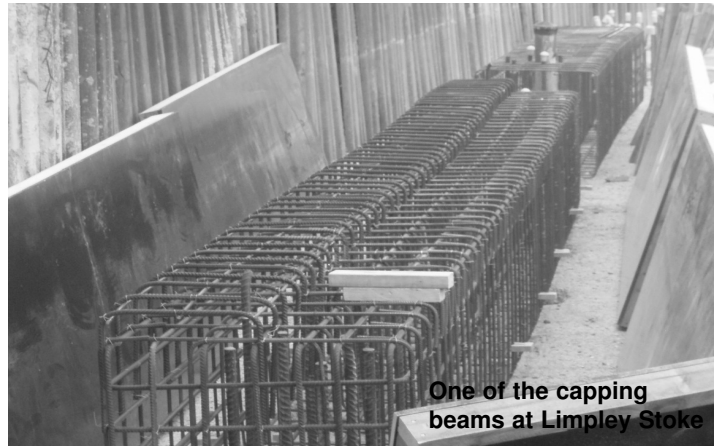
One of the capping beams at Limpley Stoke

At Limpley Stoke we have been cropping the piles (see below picture) to expose a length of the steel, in preparation for the 11 capping beams (see above picture) to be constructed on top. Each beam contains between 8 and 12 piles, which will be filled with concrete.

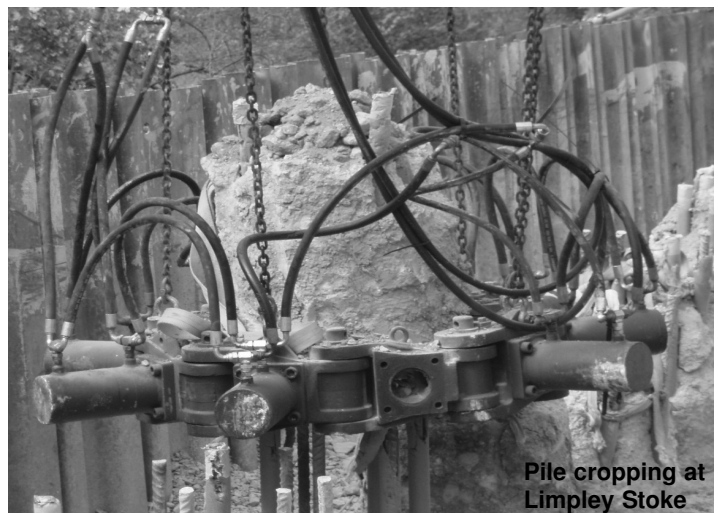
Pile cropping at Limpley Stoke
